FACE INVESTIGATION

SUBJECT: Farm Worker Dies After Tractor Overturns

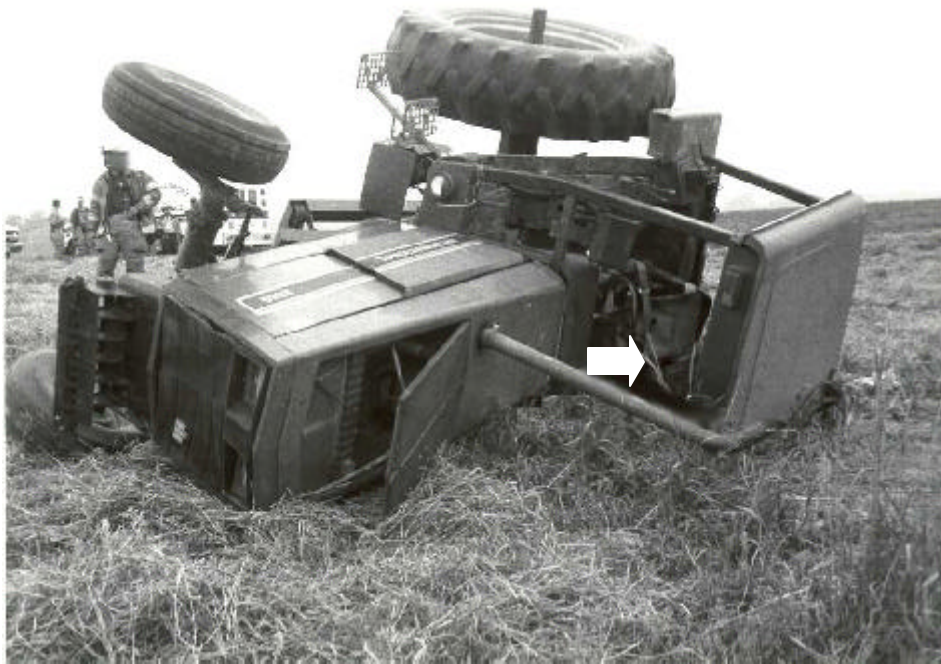
Figure 1. The arrow indicates the victim's location.
